## Metallurgical studies show EPICOR liners have lifetime exceeding 300 years

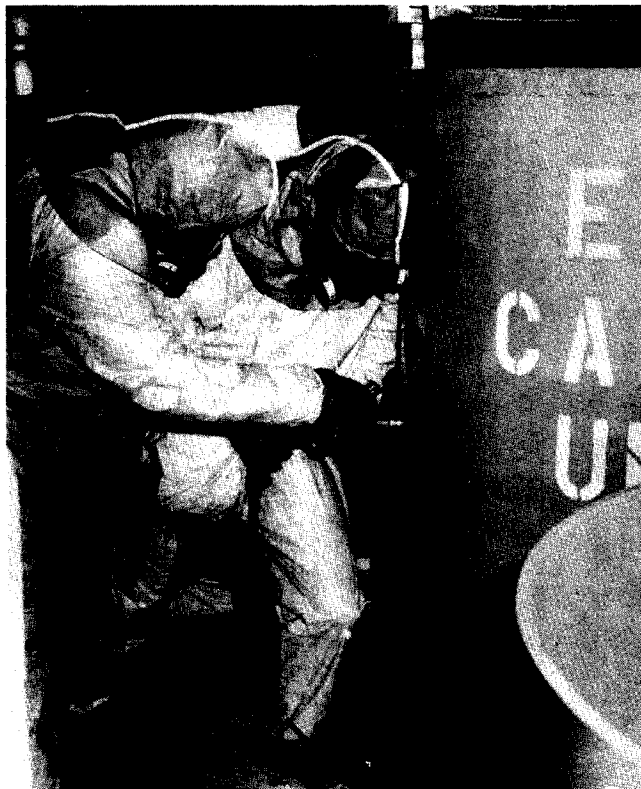
TAN HOT CELL mechanics cut a metallurgical sample from the wall of an EPICOR-II liner as part of TMI-2 research to determine the integrity of the 50 liners being placed in interim storage at the INEL.

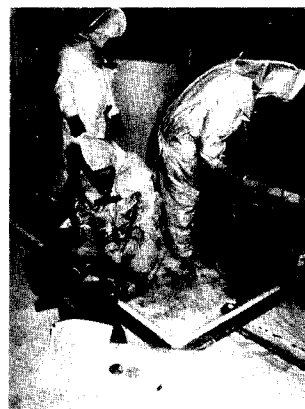
A TAN HP technician performs a radiation survey on the metallurgical sample removed from an EPICOR-II liner while mechanics clean up after the removal effort. The two discs in the foreground are typical samples which were removed from a liner.
